Field observations and interpretation of extensional fracture in hard rock surrounding deep underground openings

Charlie C. Li

NTNU Norwegian University of Science and Technology, Trondheim, Norway

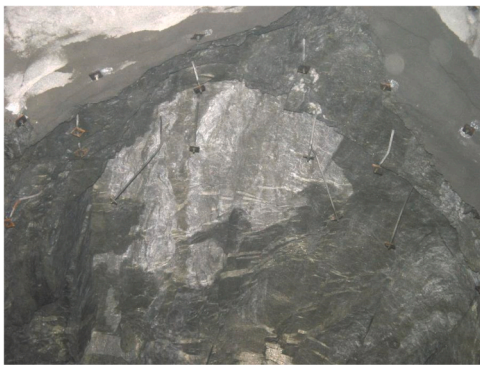
Fig. 4. Spalling on the roof of Slice 1 in SL1.

The bottom slice, i.e., Slice 1, was first excavated in SL1. The excavation face of this slice was free of stress-induced fractures. Only a few tightly healed geological discontinuities were observed on the face in addition to the sulfide mineral foliations (Fig. 3). Violent spalling occurred on the roof, and intensive noises were recorded immediately after each round of blasting during the excavation of this slice. The roof rock was ejected layer by layer to a depth up to a couple of decimeters (Fig. 4), accompanied by crisp breaking sounds. After a few hours, the superficial spalling terminated, but the burst sounds remained. These burst sounds gradually became lower-pitched and less frequent but more powerful. The burst sounds were emitted from the rock behind the roof and wall surfaces, indicating that rock fracturing was ongoing within the surrounding rock mass. Intensive superficial bursting and rock fracturing in the surrounding rock mass occurred in the first eight hours after excavation blasting; however, sparse bursting events continued to occur even beyond 24 hours after the blasting. The rock fractures developed in the surrounding rock mass were exposed on the excavation faces of the subsequent cut slices in the stope.

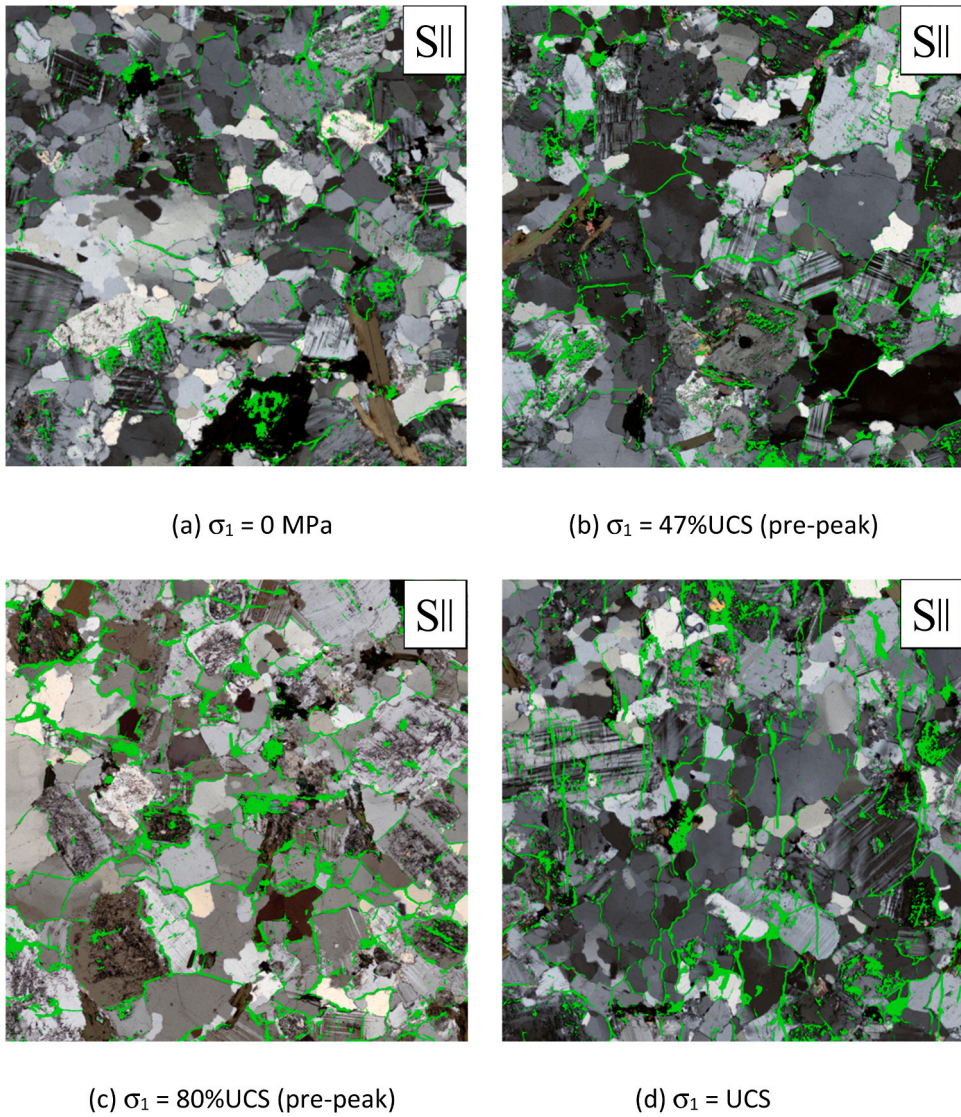
Fig. 17. Microcracks (green-colored) in the thin sections cut in the σ_1 direction of the granite specimens. [15].

microcracks in hard granite specimens under uniaxial compression. The photos in Fig. 17 show the microcracks observed in thin sections cut from four cylindrical specimens that were vertically loaded at different stress levels. Fig. 17a shows the original microcracks in the granite. The density of the cracks slightly increased at the stress level of 47% of the rock's UCS (Fig. 17b), but significantly increased at the stress level of 80% of the UCS (Fig. 17c). Most of the new cracks initiated at the grain boundaries without orientation preference at those two stress levels. However, when the stress was increased to the level close to the UCS, the cracks predominantly propagated parallel to σ_1 (Fig. 17d). In the post-peak stage, the cracks continued to propagate in the σ_1 direction until the final failure of the specimen. Fig. 18 shows the density variation of the intergranular cracks (i.e., the cracks at the mineral grain boundaries) and intragranular cracks (i.e., the cracks crossing the mineral grains) versus the stress level. These statistics reveal that both the intergranular and intragranular crack densities started to increase at a stress level approximately equal to 50% of the UCS. The density then continued to increase with increasing the applied stress in the pre-peak

Based on the microcrack observations in Fig. 17, the microcrack statistics in Fig. 18 and the AE monitoring results in Fig. 20, It is inferred that new microcracks initiate in all orientations, that is, without orientation preference, in the stress levels from σ_{ci} to σ_{cd} . However, the microcracks propagate in the direction of the applied stress σ_1 when the applied stress is beyond the crack damage stress σ_{cd} . Therefore, σ_{cd} is the strength of extensional spalling and slabbing fracture in hard rock.

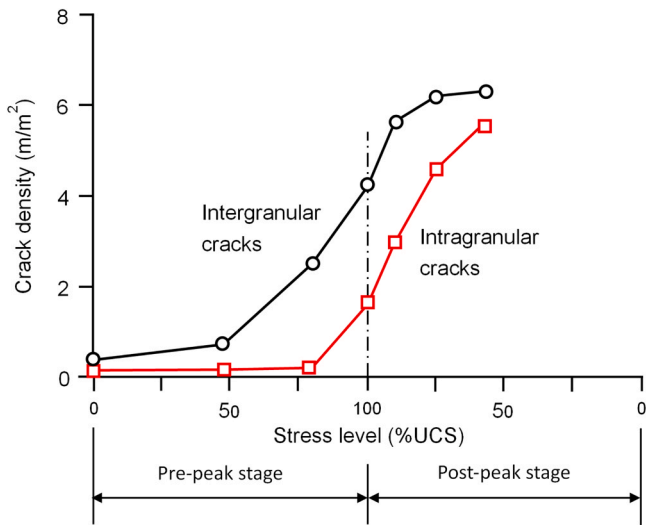
Fig. 18. Statistics describing the microcrack density throughout the loading period of the granite specimens [15].

stage and throughout the entire post-peak stage. Furthermore, the density of the intergranular cracks remained higher than the density of the intragranular cracks during the entire testing period, including both pre-peak and post-peak stages. That implies that the bond between the mineral grains is weaker than the mineral grains in the hard granite. The final failure mode of the granite specimens was splitting in the direction of σ_1 , as shown in Fig. 19, i.e., parallel to the dominant propagation direction of the microcracks within the specimen.

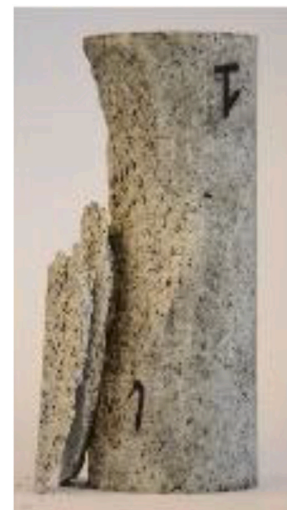
Fig. 19. The final failure mode of the granite specimen (50 mm in diameter with a length-to-diameter ratio of 2.5).
